Assessment of Crop Storage Structures in Swaziland

Y.Mijinyawa¹, M.L.Mwinjilo² and P.Dlamini³

ABSTRACT

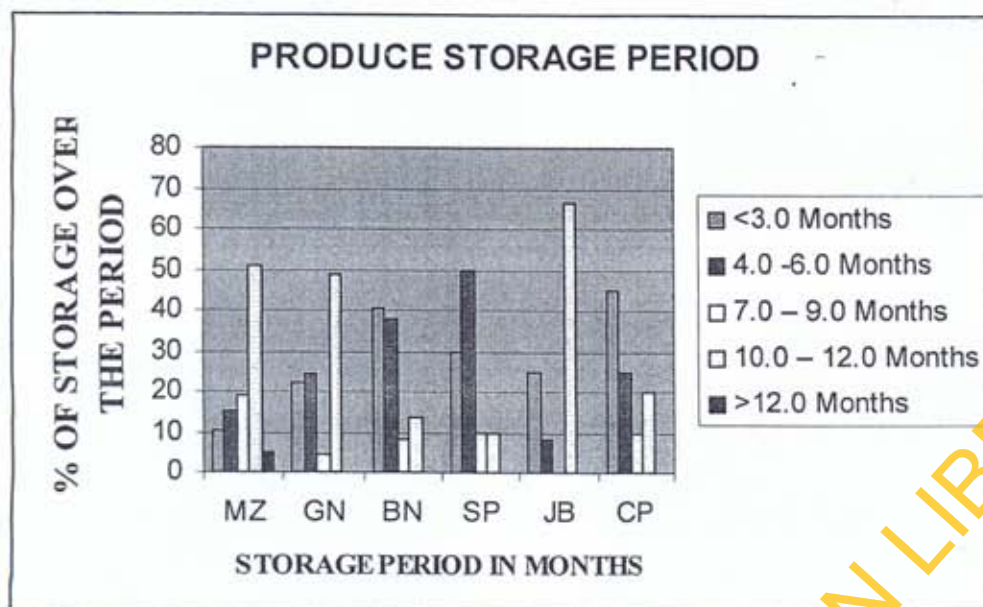
The primary determinant of storage duration was the volume of harvest on which the family depended until it is exhausted. Fig 2 shows the percentage of respondents and the periods over which they are able to store farm produce. These are periods after which the produce in the store gets exhausted irrespective of what they were being used for. From figure 2, it can be seen that only a fraction of the households were able to have produce of one harvest in store till the following harvest which is usually twelve months. This was observed in about 50.8%, 48.8%, 13.5%, 10%, 66.7% and 20% cases respectively for maize, groundnut, beans, sweet potatoes, jugobbeans, and cowpeas. Many households have to buy food especially maize to cover the period between when the family store is empty and the following harvest.

MZ = Maize, GN= Groundnut, BN = Beans, SP = Sweetpotatoe, JB = Jugobean, CP = Cowpea

Figure 2. Produce storage duration

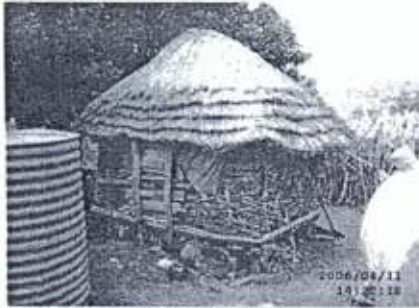
Fig. 5 Traditional crib

The crib is traditionally used as a drying structure and it is only on a few occasions that it is used for storage. The maize cobs, after harvesting, are left in the crib to dry for between one and three months after which they are shelled and put in the tank. For this reason, most of the cribs are constructed annually and after the maize is dried and removed, the structure is destroyed. The few that are used for storage are provided with a roof and are given minor maintenance. Fig.5. At present, the Crop Storage Unit is popularizing the improved cribs among farmers. The improved crib involves the use of durable wooden members, metal and wire mesh and is also provided with a roof made from corrugated roofing sheets. Besides drying, the structure is also being popularized for use in produce storage.

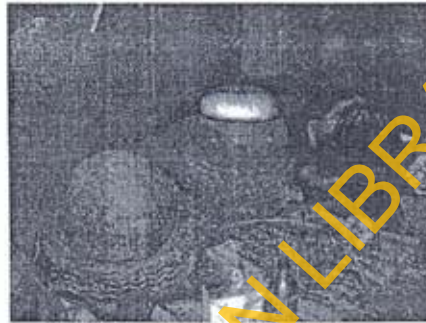
Fig. 6 Clay pots for crop storage

Earthen pots are used for the storage of produce such as beans, groundnut and jugobbeans which are in most cases stored in small quantities and serve as planting materials. (Fig. 6)

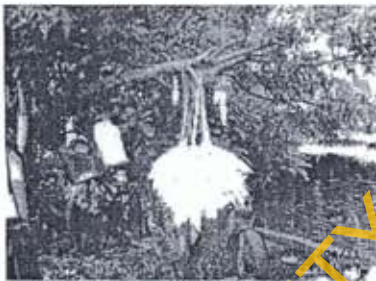
Fig.7 The use of tree branches for crop storage

Maize cobs with some of the sheath can be knotted and suspended from tree branches (Fig.7). This is used mainly for maize intended to serve as planting material.

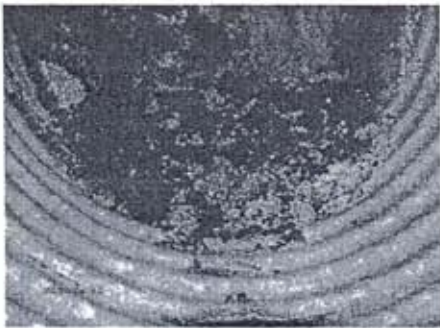
Fig. 9 Caked and moulded maize at the bottom of a metal tank

Joint failure and hence the entry of moisture and rusting were the commonly reported problems for metal maize tank. (Figs. 9 and 10). Moisture penetration was reported in 33%, rusting in 25% while joint failure was reported in 21% of cases. Two factors are responsible for this observation. One is poor workmanship and the other has to do with management. As a result of

While metal tanks provided adequate screen against rodent attack, insect infestation, moulding, germination and caking were experienced in 41.3%, 21.2%, 2.3% and 6.3% of cases respectively.

Maize in crib get infested	Remove and take to tank
When caking takes place in metal tank	Open the tank to allow air circulates.
Leaking roof in warehouses/houses	Replace roofing sheets or increase thickness of thatching material.

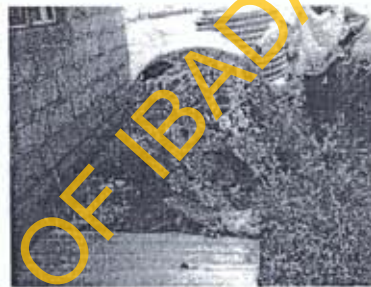
Fig.10 The corroded bottom of a maize tank, a common problem in many households.

poor workmanship, the soldering is poorly done and this tends to crack with time allowing moisture penetration through the joint. This was observed during visits to artisans fabricating metal tanks. It was noted that the spacing of rivets holding together the tank vertically and along the circumference were varied between artisans. The spacing between rivets varied from 0.5 m to 1.00m vertically and 100 mm to 150 mm along the circumference. It is expected that if the rivets are far apart, the structural stability would be affected. Considering that solder does not have any strength, cracks would result. Another observation was that the solder was applied thinly and any slight structural instability would result in the appearance of cracks. Metal tanks should ideally be indoor or under a roof and raised above ground level to ensure adequate ventilation underneath. It was observed that in about 60% of cases, the metal tanks were unprotected from the inclement weather. Many of them were rested on the ground and where attempts were made to raise them, the supporting platform did not make provision for ventilation underneath. Besides the entry of moisture through cracked solder, the outdoor tanks were subjected to severe temperature fluctuations which resulted in the condensation of moisture on the walls of the tank and its migration to the core of the stored material over time. Rusting especially at the bottom is also a common problem with the maize metal tank.

1. The use of rat guards in cribs and platforms should be vigorously promoted to minimise post harvest losses.
2. Metal tanks and other storage structures should be cleaned thoroughly and disinfected immediately they are empty and just before storing produce.
3. To minimise joint failure in metal tanks, the recommended rivet spacing should be adhered to while the amount of solder used should be that which would minimise or eliminate cracking.

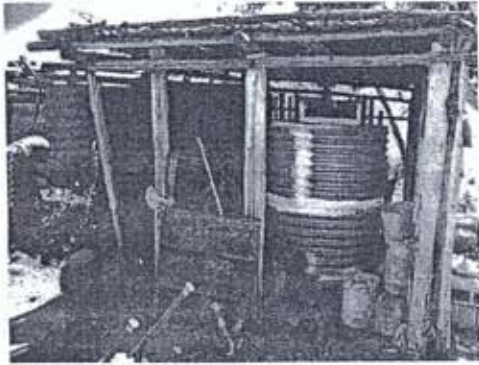
Fig. 11 Failed joint in metal tank, re-soldered and painted over as shown by the white vertical and horizontal strip. Also shown are metal drum and assorted containers which are also used for storage

Problem	Remedial measure
Joint failure in metal tanks or cracking of soldering	Solder and paint over (see fig. 11).
Insect infestation in various structures	Use weevil and other tablets, dry pepper and ash.
Moulded grains in metal tanks	Regularly inspect tank. Remove grains and clean tank for reuse, sun dry grains and use as possible
Leakage of metal tank	Solder points of leak, cover openings with rags
Rusting	Paint over rusted portion
Rodents attack in cribs	Use cats around the structure, use rodent glue, rattex and rat guards Clear surroundings where rodents may hide.
Collapse of platforms and cribs	Use treated poles and poles of bigger sizes Replace members and in some cases the entire structure is reconstructed after two or three years
Insect infestation in produce stored in bags	Winnow to remove powder and insect
Grains germinate in drums	Empty drum, remove germinated ones and feed to chicken and put the rest in the sun to dry and either used immediately or restored
