# Performance Assessment of Installed Solar PV System: A Case Study of Oke-Agunla in Nigeria

Olawale Saheed Ismail, Olusegun Olufemi Ajide\*, Fredrick Akingbesote

Department of Mechanical Engineering, University of Ibadan, Ibadan, Nigeria

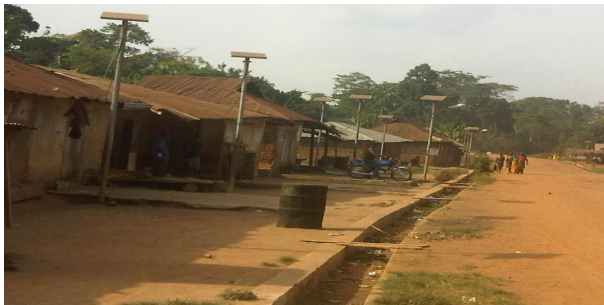
**Figure 2.** Installed solar street lights in Oke-Agunla, Ondo State, Nigeria.

The solar street lights numbering 10 are all off-grid solutions. They are AC powered with top-of-pole mounted solar modules. In the first few months of installation, the beneficiaries enjoyed night lighting from dusk to dawn every night and the photocell intelligence worked as installed. However, the system performance began to deteriorate at about 28 months. The deficiencies noticed in the SSL infrastructure are twofolds. Due to the short length of the light poles, the distance between light poles were short, and this means there are more poles being used. From design perspective, the higher the poles, the fewer the number to be used because of the wider area of illumination coverage. Paint coating on the poles are peeling off. The silver paint coating on the lighting poles has been peeled off, leaving a rusty surface. Use of none galvanized metal poles. The metal poles used for the lighting system were not galvanized. Galvanized metal poles have higher corrosion resistance than non-galvanized materials. Poor Aesthetics was noticed where good design and finish were not given a priority on the SSL job. The battery box height was rather low, making it easily accessible to unauthorized people. Earth wires in some installed were hanging which has exposed a substantial number of the earthen wires to abuse by passer. The SSL lamps were AC powered hence, each unit has an inverter embedded to invert the DC. This led to some power losses.

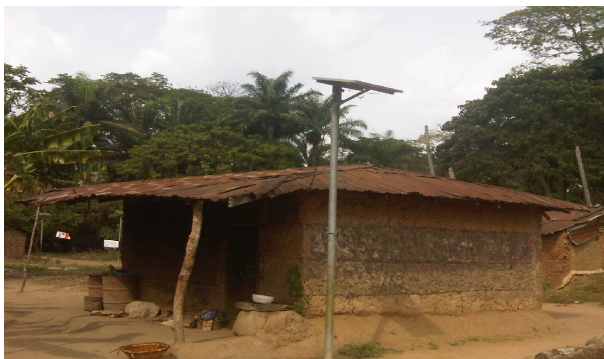
**Figure 3.** Installed home solar lights.

All the fourty stand alone systems are off-grid solutions. Each unit consists of two components; outdoor unit and indoor unit. The outdoor unit is a top-of-pole mounted single 70W solar module, working at 5.5 peak sun hours per day, the module has the capacity to generate 385 Watt-Hrs per day baring system losses. Performances were quite good at installation. However, due to system inadequacies bothering on maintenance, the effectiveness was short lived. A large number of the systems stopped

working thirty months after installation. Deficiencies in terms of delivered energy inadequacy are enormous. While the SHS passed the proof of concept as a viable source of electricity for rural dwellers, this particular deployment (Oke-Agunla solution) failed to go beyond meeting the need for just 2 lighting points (Lighting) in the homes. A typical home (urban or rural) conforms to the lighting, ventilation, entertainment, refrigeration, Air Conditioning, Heating and Cooking. LIVERAHC, a residential energy requirement model, whereby lighting L is the most basic electricity need. Almost all electrical household appliances in Nigeria are AC powered. However, the deployed SHS pumps out only DC power to run the lights and provide a single power outlet for DC appliances. Therefore, except a householder invests a converter; almost no other appliance in the house may run off the provided electricity. Lack of spares for component replacement and mishandling of cables by unauthorized persons also constituted the deficiencies.
