AIRCRAFT DISASTERS – ROLES OF MATERIALS

T. B. Asafa^{a*}, M. O. Durowoju^a and O. S. Ismail^b

Abstract

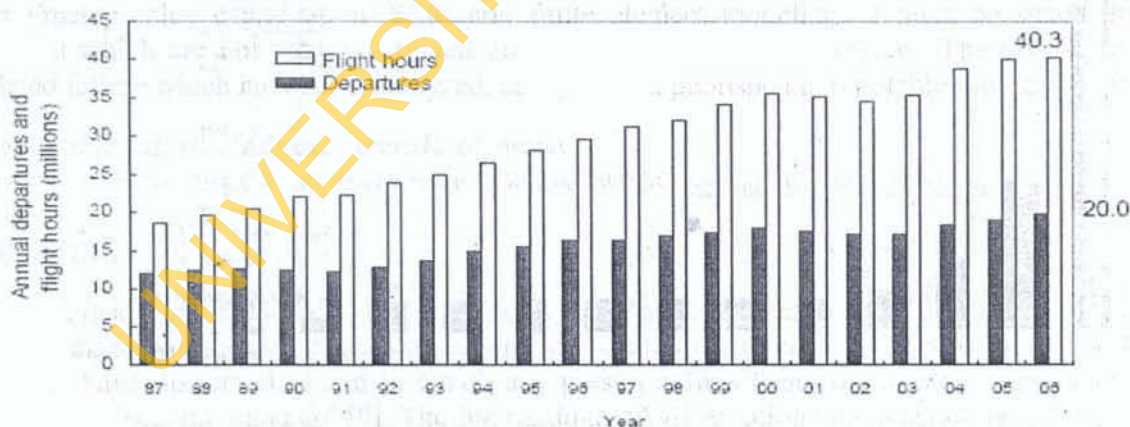
Fig.1: Annual departures and flight hours between 1987 and 1996 [9]

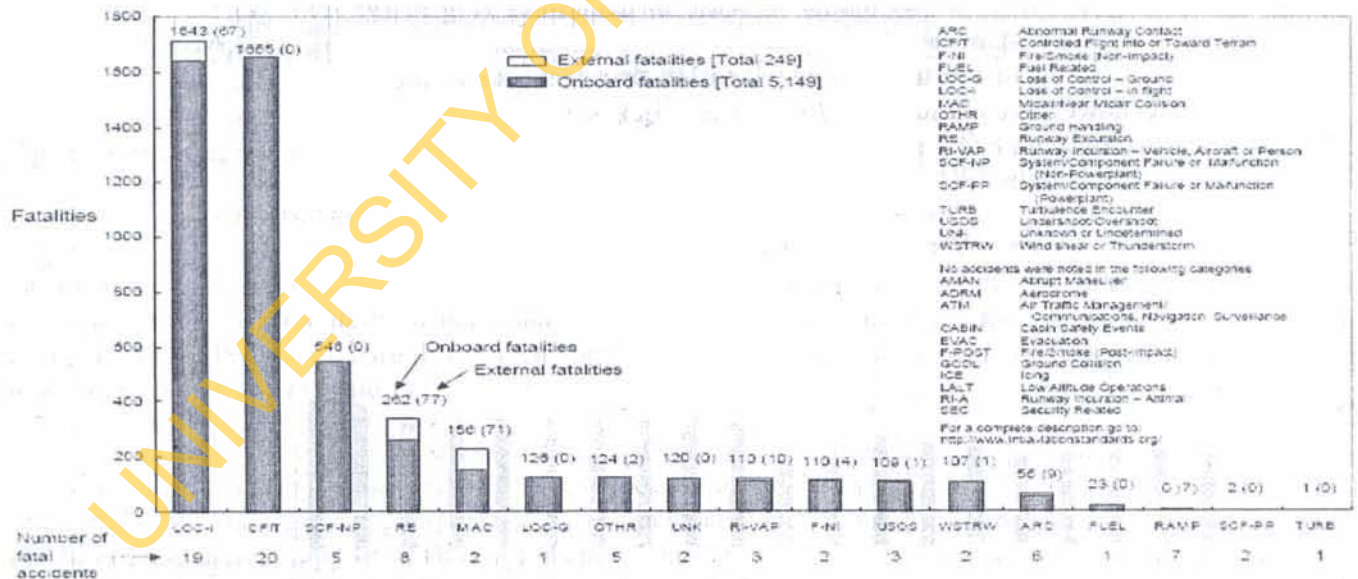
A comprehensive statistical analysis of aviation accident involving worldwide commercial Jet fleet from 1997 through 2006 is provided in Fig.3. The categorisation was based on Fatalities by CAST / ICAO Taxonomy Accident category. The figure indicates that loss of control is the highest cause of aviation accident followed by system component failure (which related to material failure). In a similar report, 13% of total aircraft accidents since 1950 was caused by mechanical failure while loss of control is attributed to over 31% with reference to on-board fatalities[11].

Fig.3: Fatalities by CAST/ICAO Taxonomy Accident Category [9]

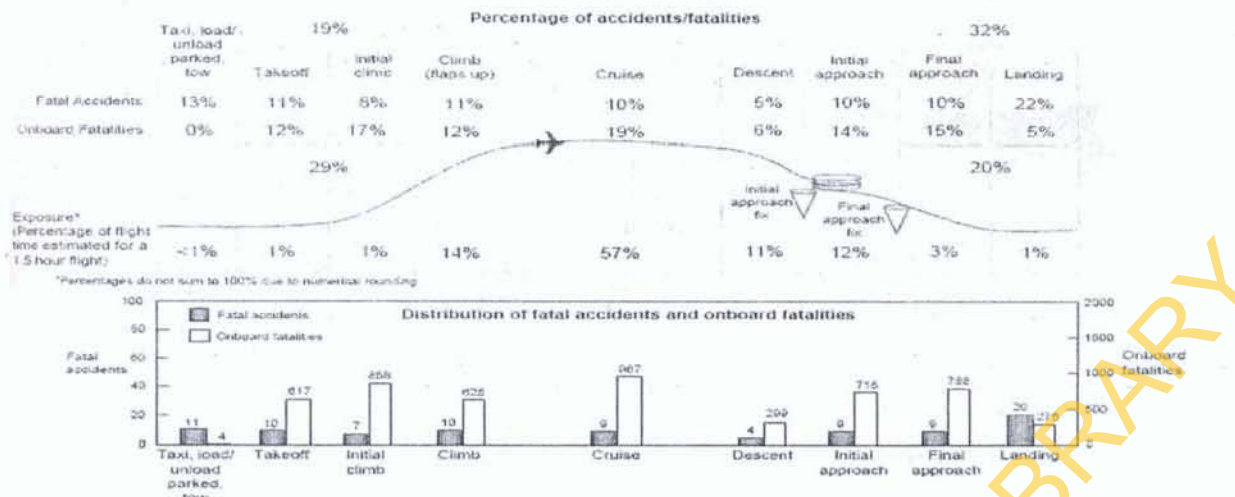
Further statistical analysis was conducted to categorise these accidents according to flight phase. Fig.4 (accident phase) clearly indicates that fatal accident happened most during landing phase while on-board fatality is zero during taxiing [9]. Most of the accident and fatalities are associated with departure (take off/climb) and arrival (approach/landing) phases. 'During these phases, aircraft is close to the ground and in a more vulnerable configuration than in other phases of flight' as manoeuvre margin is greatly reduced [12]. Take off and initial landing account for 29% of on-board fatalities while 20% is attributed to final approach and landing. These are higher in comparison to 19% observed during cruise stage.

Fig.4: Fata accidents and onboard fatalities by phase of flight [9].

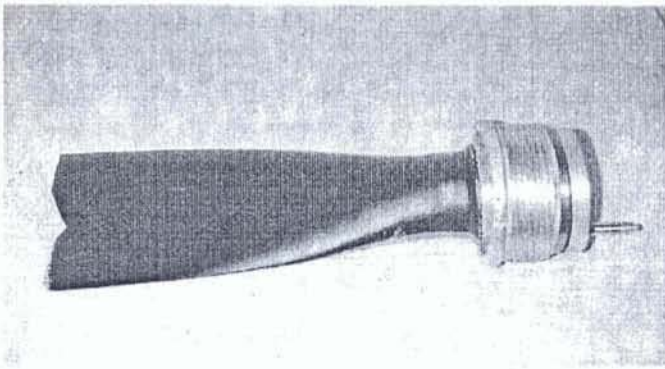
An investigation conducted on the failure of a Cessna-185 aircraft revealed that the disaster was brought about by fracture of its propeller [2]. One of the propeller blades (Fig.5) was broken up during flight. The propeller was made of high strength 2024 aluminum alloy commonly used in aerospace industry.

Fig.5: Broken propeller of the airplane [2].

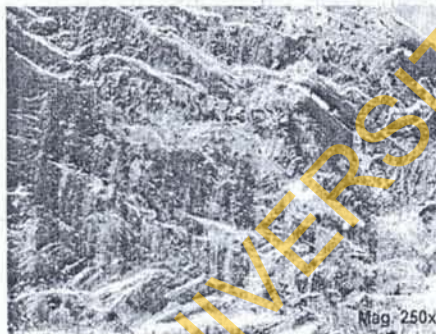
Fig.8: Zone I semi-elliptic striations [2].

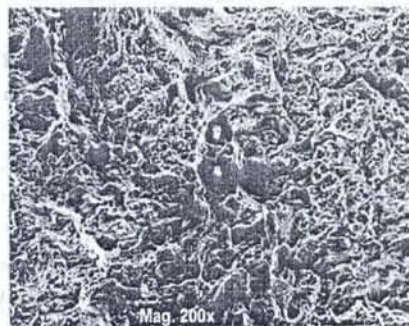
Fig.9: SEM image of zone II [2].
