### Termite Mound Clay as Material for Grain Silo Construction

Yahaya Mijinyawa<sup>1</sup>, E.B.Lucas<sup>1</sup> and F.O.Adegunloye<sup>2</sup>

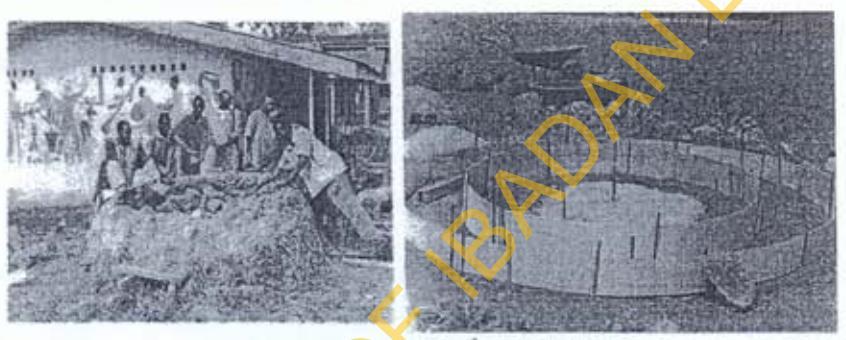
Figure 1: Dried termite mound bricks being Figure 2: Veneers and iron rods used to mark set for burning in a mud-kiln the circular foundation

In order to be able to obtain clay from the mounds, the termites were evacuated through the application of chemical powder (pestox) into the broken mounds and the surroundings. The lumps of termite mound clay were then collected and deposited at a clean site. Size reduction of the clay lumps was achieved through pounding with pestle. The clay was then mixed with water in the ratio of two volumes of termite mound to one volume of water. The wet clay was then poured into a 215 x 150 x 65 mm wooden mould placed in a manually operated moulding machine and vibrated to ensure compaction and appropriate shape forming. The bricks were then removed and left for five days to dry naturally. They were thereafter burned in a mud-kiln with the use of firewood as the source of heat (Figure1). The kiln temperature was about  $500^{\circ}$ C monitored with a thermocouple.

In order to define the perimeter of the silo foundation, the two ends of a 1300 mm long binding wire were tied to 30 cm long iron rods. One of the rods was placed at the proposed centre of the silo while the other was used to draw a circle defining the outer radius of the silo. The foundation was excavated and the footing cast. Strips of 30 cm height were obtained from 3 mm thick veneer and bent to form the inner and outer circumferences of the foundation and supported at intervals with iron rod pegs (Figure 2). Stones were then used to construct the foundation. The foundation was filled with laterite after which a concrete floor of 1:3:5 mix and 40 mm thickness was constructed. The floor was slopped at 8° towards the discharge chute in order to aid grain discharge. Figure 3.

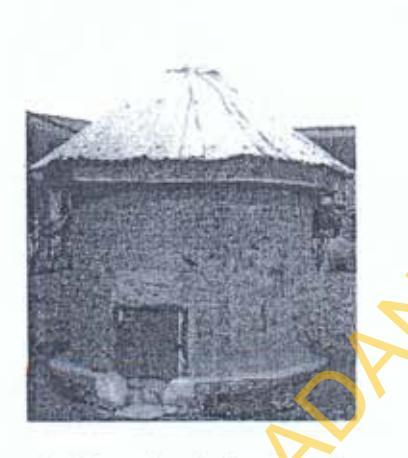
Figure 7: Completed silo showing the manhole to which the discharge chute is attached

The silo accessories were the loading and discharge chutes, and the manhole for inspection . The loading chute comprised of a trapezoidal wooden frame of 400 mm x 300 mm and height of 300 mm and attached to the roof truss (Figure 6). The chute was covered with a removable roofing sheet with the hinge points provided with rubber gaskets to eliminate moisture entry into the silo. The manhole provided entry into the silo to carry out any necessary repairs and cleaning. This was located on the wall towards the base and measured 560 mm x 480 mm. The discharge chute of dimensions 160 mm x 150 mm formed part of the manhole. Loading was accomplished with the use of a ladder which was only in place when loading was to be done. The completed silo is shown in Figure 7.
