## **Corrosion Behavior of 18/8 Stainless Steel and Nickel-Plated Low Carbon Steel in Cassava Fluid**

*This research work investigated the corrosion resistance of nickel-plated medium carbon steel and 18/8 stainless steel in cassava fluid (i.e. containing hydrogen cyanide). It simulated the effect of continuous use of the materials in a cyanide environment where corrosion products are left in place. Low carbon steel sample was nickel electroplated at 4V for 35 minutes. The plated sample, the unplated and the 18/8 stainless steel were then subjected to a cassava fluid environment for thirty days. The electrode potentials, in mV (SCE), were measured every day. Weight loss was determined at intervals of 5 days for duration of the exposure period. The result showed little corrosion attack on the nickel-plated steel on the fifth and tenth days which quickly dropped to zero by the 15<sup>th</sup> day and remained at the passive state till the 20<sup>th</sup> day when corrosion picked up again increasing steadily, linearly until the end of the test day. Corrosion of the 18/8 stainless steel was very low as well decreasing till the last day of the test. The pH of the cassava solution whic

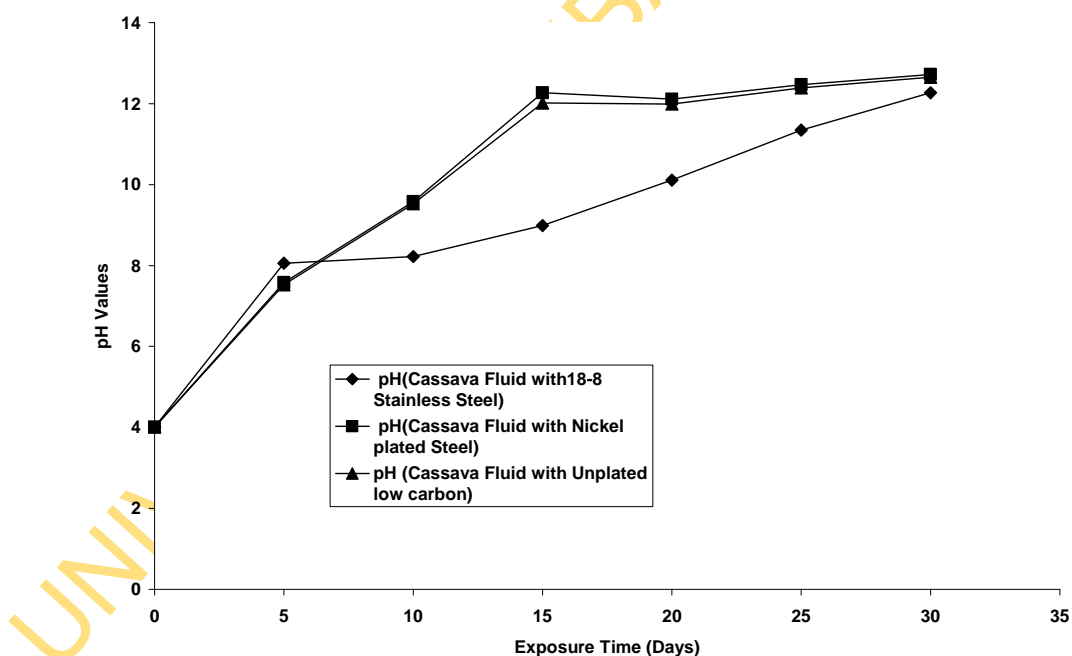
Table 1 shows the nominal chemical composition of the steel samples used while Table 2 shows the average properties of cassava fluid. The electroplating mass gains, and corresponding coating thicknesses value, for the zinc plated steel sample is shown in Table 3. Figure 1 shows the variation in pH values for cassava fluid during the corrosion test period. It shows the pH of the corrosive fluid changing from acidic to neutrality and then to alkalinity at the end of the corrosion test.

**Fig. 1.** Plot of pH values of Cassava Fluid during Corrosion of 18-8 Stainless Steel and the Low carbon Steels.

The un-plated sample showed potential increase from the fifth day till the thirteenth day after which it started decreasing again and relatively rapidly moved to values consistent with the exposure of bare steel (-550mV, SCE). The pH change during the immersion was significant. By the fourth day, pH had become neutral and on the 8<sup>th</sup> day was already alkaline. This affected the potential of the sample in the corrosion environment. Visible corrosion product for steel (i.e. rust) was apparent from early immersion resulting in the changing pH values.

The extent of susceptibility to corrosion in natural fluids depends on the aggressiveness of chemical reactivities, transport properties of environment, concentration of corrosion species in the medium (pH), the metallurgy of the alloy sample and temperature of the corrosion medium<sup>9</sup>. In the cassava fluid, the corrosion rates of all the samples were observed to be influenced extremely by the changing pH of the corrosion environment. Corrosion rate of the 18/8 stainless steel decreased steadily after the fifth day because the pH had changed from acidity to alkalinity within five days. This decreasing trend continued till the last day of the test.

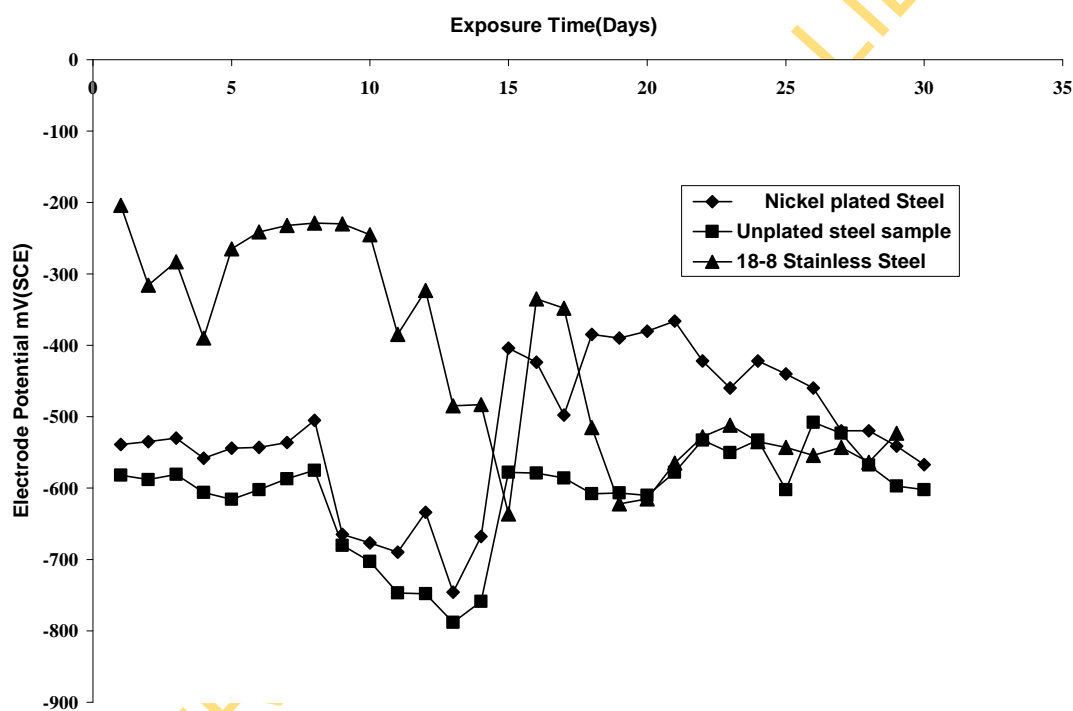
Figure 2 shows the variation in the electrode potential in mV obtained for 18/8 stainless steel, un-plated and nickel plated low carbon steel samples at various electroplating times.

For the unplated sample, the electrode potential increased from the fifth day until the thirteenth day after which it started decreasing again and relatively rapidly moved to values consistent with the exposure of steel. The nickel-plated steel started with a slightly higher potential than the unplated steel but followed the same trend as the unplated steel till the thirteenth day when it decreased into passivity from the fifteenth to the twentieth day.

After the 20<sup>th</sup> day, the potential started increasing again showing renewed corrosion activity. 18/8 stainless steel showed a cyclical trend of increase and decrease in potential from the first day till the 21<sup>st</sup> day when a steady plateau was reached till the 30<sup>th</sup> day.

**Fig. 2.** Plot of Electrode potential Versus Exposure Time for 18/8 Stainless Steel and unplated and nickel plated low carbon steel samples

The plated sample's trend of increasing potential from the fifth day till the thirteenth day when it decreased into passivity till the twentieth day is traceable to the changing pH of the corrosion environment as well. After the 20<sup>th</sup> day, the potential started increasing again showing renewed corrosion activity.

18/8 stainless steel showed a cyclical trend of increase/decrease in potential from the first day from a potential of -200mV(SCE) until the 23<sup>rd</sup> day when it settled in the potential characteristic of bare steel(-550mV(SCE)) till the last day of test. The pH of the corrosive environment was seen to move from acidic to neutral and to alkalinity within 5 days. This significant trend affected the potential as well as the corrosion activity.

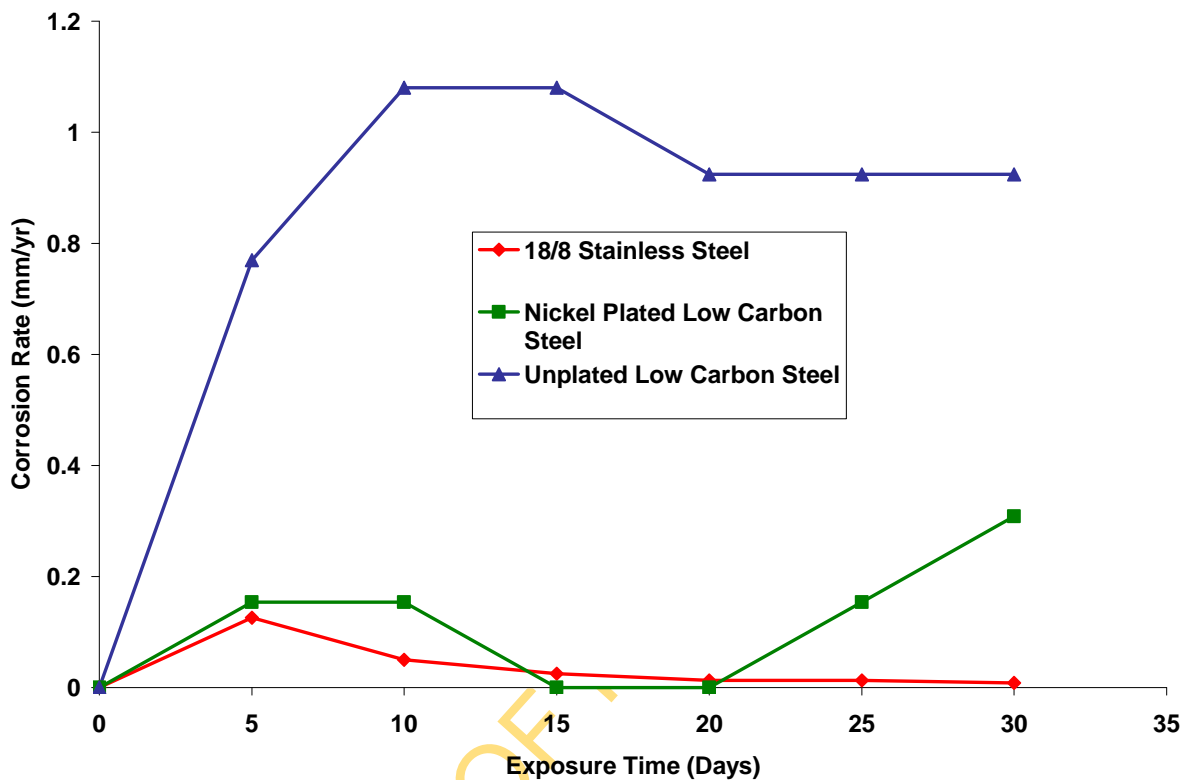
Figure 3 shows the variation of corrosion rate in mm/yr for 18/8 stainless steel, the nickel plated low carbon steel sample as well as the corrosion rate of the un-plated sample immersed in cassava fluid. It shows a relatively low corrosion rate experienced by the nickel plated steel in the first 10 days of immersion compared to the corrosion rate of the unplated steel. Corrosion rate was observed to drop to zero on the 15<sup>th</sup> day and remained zero till the 20<sup>th</sup> day when a renewed corrosion activity commenced and increased linearly till the end of the test. The 18/8

stainless steel had relatively very low corrosion rate compared to the unplated steel in the first five days. The corrosion rate continued to drop till the end of the test.

**Fig. 3.** Superimposed Plot of corrosion rate Versus Exposure Time for 18-8 Stainless Steel, Nickel Plated Low-Carbon Steel And the Unplated Low Carbon Steel

For the nickel plated sample, there was active corrosion activity up to a pH of 12 which was the 15<sup>th</sup> day of exposure in the corrosion environment. Passivation was observed at a pH of 12 which was the 15<sup>th</sup> day and moved out of passivation on the 20<sup>th</sup> day with a pH of 12.5. Thus, the corrosion rate for the nickel plated sample went into passivity with no corrosion occurring on the 15<sup>th</sup> to 20<sup>th</sup> days when the pH hit 12 and at a pH of 12.5 renewed corrosion activity began. This is showing that E-pH diagram for Ni-CN<sup>-</sup> prevalence diagram has a thin passive segment between pH of 12 and 12.5 after which corrosion species become prevalent.

The unplated steel was experiencing increased high level corrosion activity up till the fifteenth day rising from a pH of 4.0 to 12 after which there was a decrease in corrosion rate on the 20<sup>th</sup> day remaining constant till the end of the test. This decrease corresponds to the decreased potential from -770Mv(SCE) to -550Mv(SCE) which is characteristic of bare steel and this potential remained steady till the end of the test.
